# Service Bulletin

## SAFETY RECALL

### 2008-2010 ST1300/A/PA Rear Master Cylinder Reservoir Hose Replacement

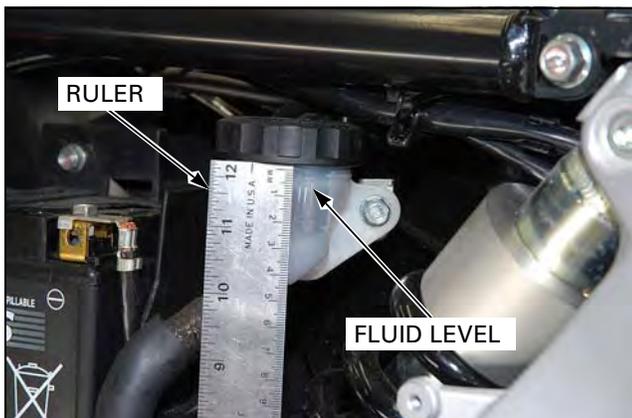
2. Measure and record the brake fluid level in the rear master cylinder reservoir as shown.

**NOTE:** It is important to record the fluid level so that the reservoir is NOT overfilled after the repair procedure. A topped off reservoir becomes overfilled when brake pads are replaced with new ones later, causing brake drag.

- Dealer new inventory units - fill the master cylinder reservoir to the UPPER level mark.
- Customer units - adjust the fluid level in the reservoir to the same level recorded in Step 2. If the recorded level was below the LOWER mark, inspect the brake pads for wear. If the pads are serviceable, fill the reservoir half way between the UPPER and LOWER level marks.

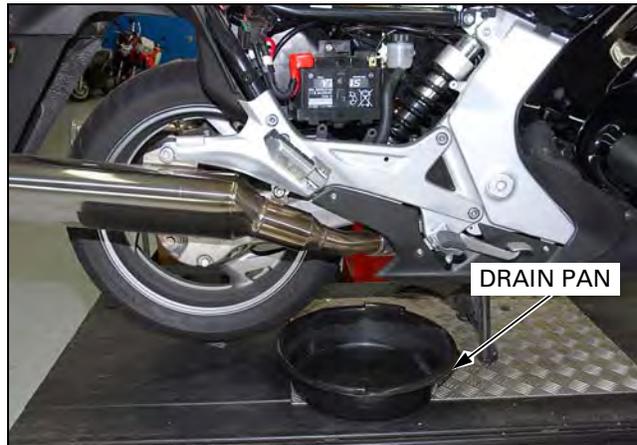
3. Place an oil drain pan under the rear master cylinder assembly to catch spilled brake fluid.

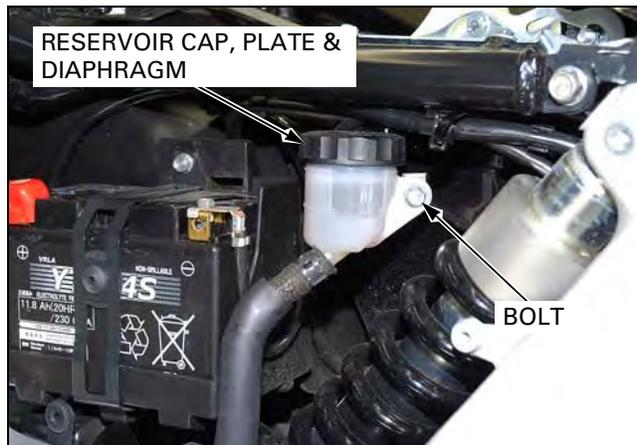
4. Remove the bolt from the rear master cylinder reservoir.  
Remove the reservoir cap, plate, and diaphragm and place them on a clean surface.

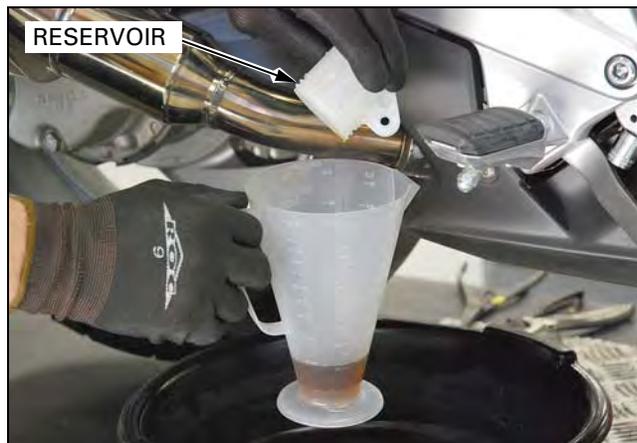
5. Carefully turn the reservoir over and pour the brake fluid into a suitable container.

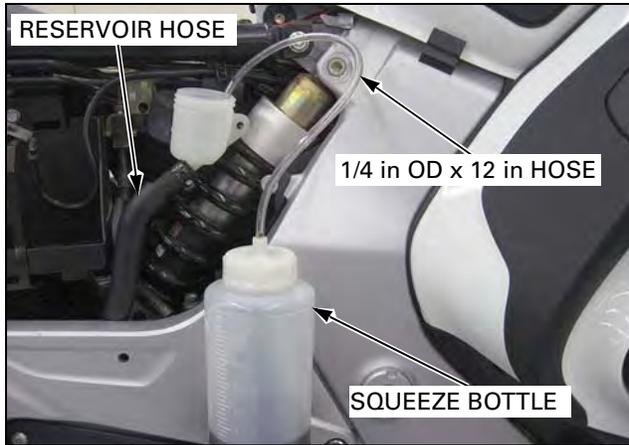
6. Using a suitable squeeze bottle and a 1/4 in OD x 12 in long hose, siphon the remaining brake fluid from the bottom of the reservoir hose as shown. This will ensure that very little brake fluid is spilled later.

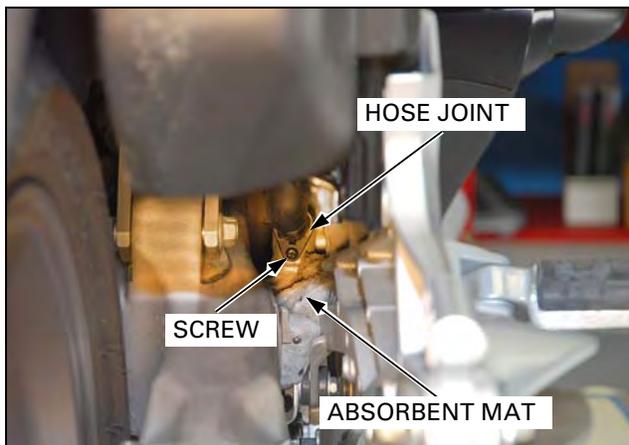
7. Wedge a piece of absorbent mat directly behind the rear brake master cylinder, below the hose joint as shown. Remove the screw and pull the reservoir hose joint backward from the master cylinder as shown.

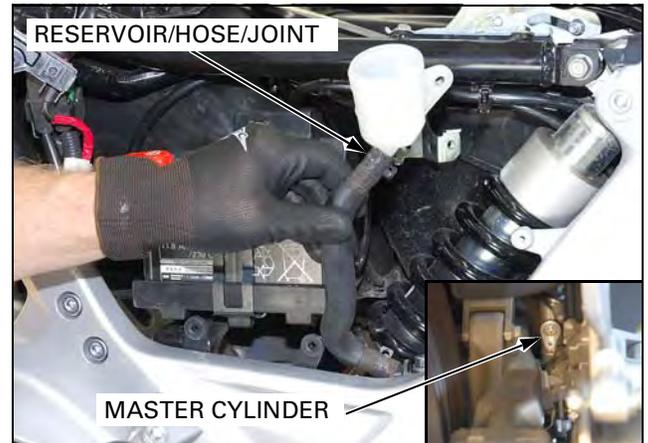
8. Remove the reservoir and hose/joint from the motorcycle upward as shown. Immediately wipe off any spilled brake fluid from the motorcycle.

Wipe off any brake fluid from the rear master cylinder hose mounting surface.

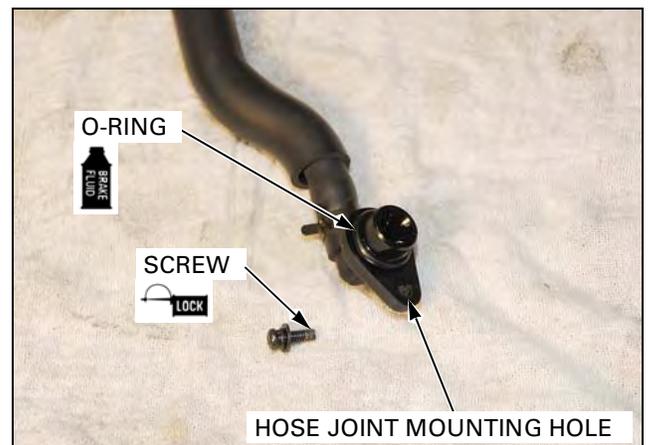
9. Apply brake fluid to the O-ring on the update reservoir hose assembly as shown. Make sure that brake fluid does not get onto the hose joint mounting hole.

Apply locking agent to the reservoir hose joint screw threads.

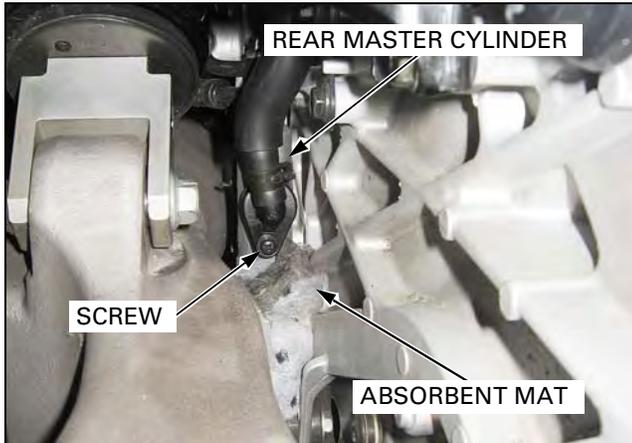
10. Install the update reservoir hose joint into the rear master cylinder as shown.  
Install and tighten the screw to the specified torque.

**Torque: 2 N·m (.15 kgf·m, 1.1 lbf·ft)**

Remove the absorbent mat from behind the master cylinder.

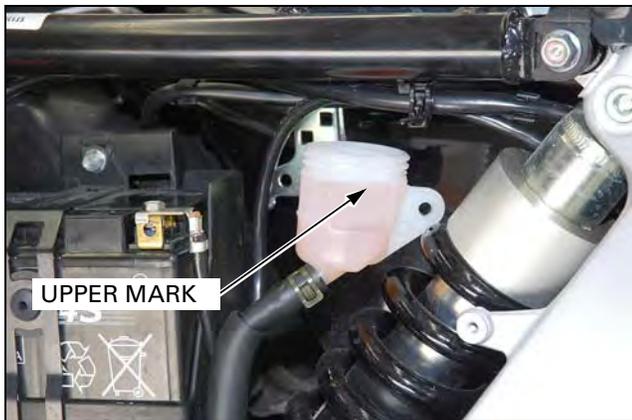
11. Temporarily fill the reservoir to the UPPER level mark with DOT 4 brake fluid from a sealed container.

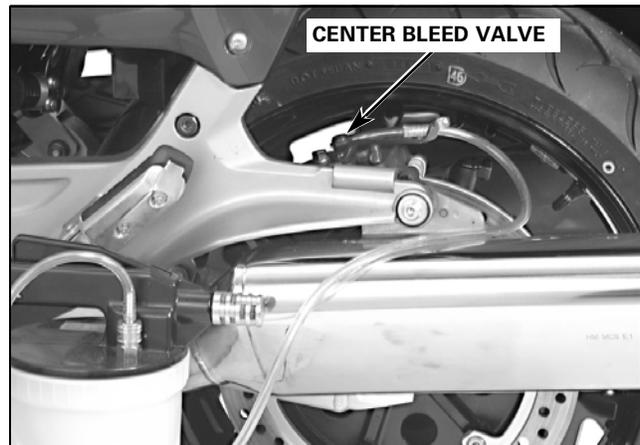
A. Connect a commercially available brake bleeder (See STN #16) to the center bleed valve of the rear caliper. Operate the air bleed tool and loosen the bleed valve, adding fluid when the rear master cylinder reservoir is low.

Close the bleed valve.

**Torque: 6 N·m (0.6 kgf·m, 4.3 lbf·ft)**

**TECH TIP:** *If air is entering the bleeder from around the bleed valve threads, seal the threads with teflon tape.*

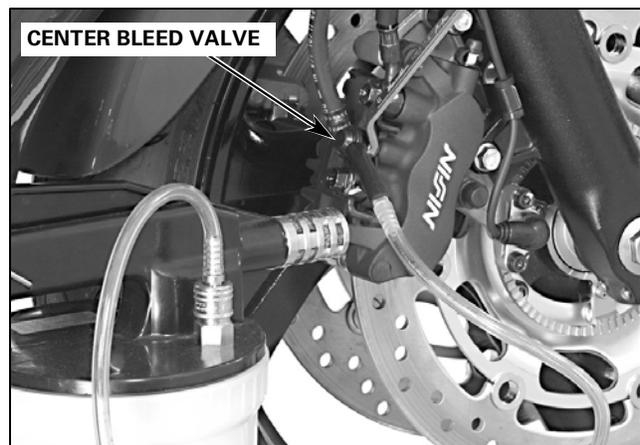
B. Connect the brake bleeder to the center bleed valve of the *right* front caliper. Operate the air bleed tool and loosen the bleed valve, adding fluid when the rear master cylinder reservoir is low.

Close the bleed valve.

**Torque: 6 N·m (0.6 kgf·m, 4.3 lbf·ft)**

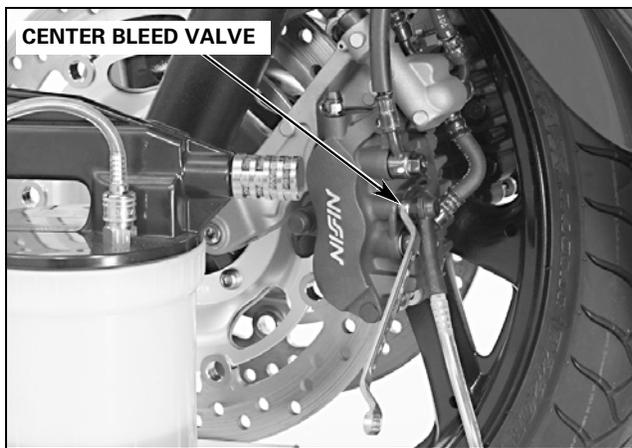
C. Connect the brake bleeder to the center bleed valve of the *left* front caliper. Operate the air bleed tool and loosen the bleed valve, adding fluid when the rear master cylinder reservoir is low.

- If air is *not* bleeding from this valve at this time, close the bleed valve and finish the brake bleeding here, then proceed to Step 15.

- If air *continues* to bleed from this valve it will be necessary to bleed the Servo Brake Line, proceed to Step 13.

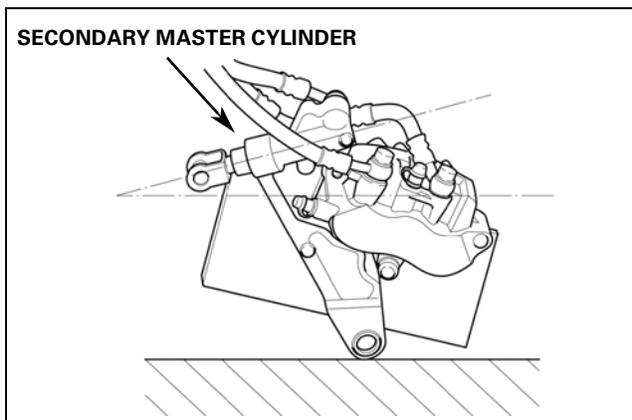
A. Remove the left front brake caliper/bracket assembly, tilt the caliper about 0-15° from horizontal as shown.

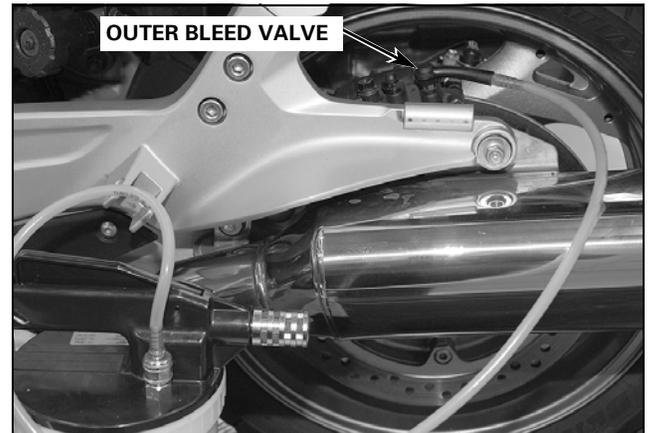
B. Connect a commercially available brake bleeder to the *outer* bleed valve of the rear caliper. Operate the air bleed tool and loosen the bleed valve, adding fluid when the rear master cylinder reservoir is low.

Close the bleed valve.

**Torque: 6 N·m (0.6 kgf·m, 4.3 lbf·ft)**

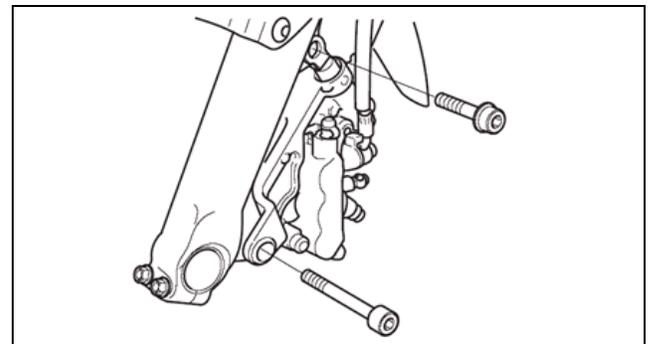
14. Reinstall the left brake caliper/bracket assembly over the brake disc. Tighten the bolts to the specified torque.

**Torque: 31 N·m (3.2 kgf·m, 23 lbf·ft)**

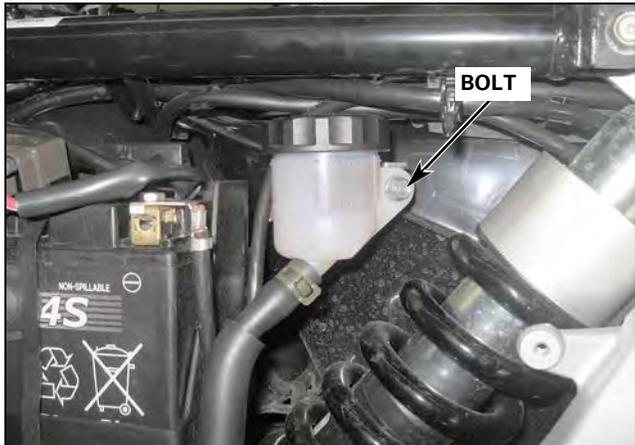
17. Install the rear master cylinder reservoir and tighten the bolt to the specified torque.

**Torque: 12 N·m (1.2 kgf·m, 9 lbf·ft)**

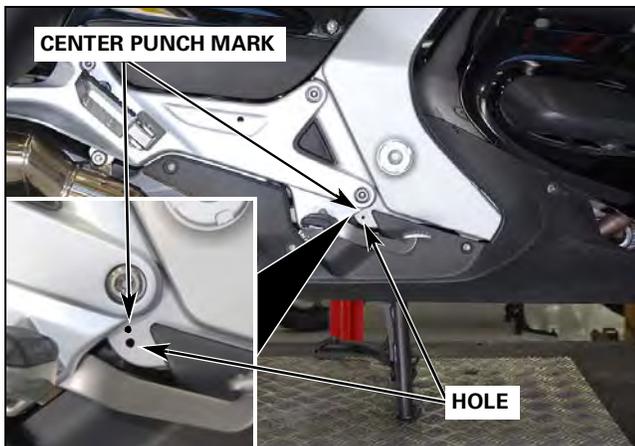
After you have completed the REPAIR PROCEDURE, apply a center punch mark on the frame just above the hole and below the right footpeg bracket as shown.

- If there is a punch mark on the right side of the frame near the brake pedal – No further action is necessary.

Factory punch mark:	✦
Dealer center punch mark:	●

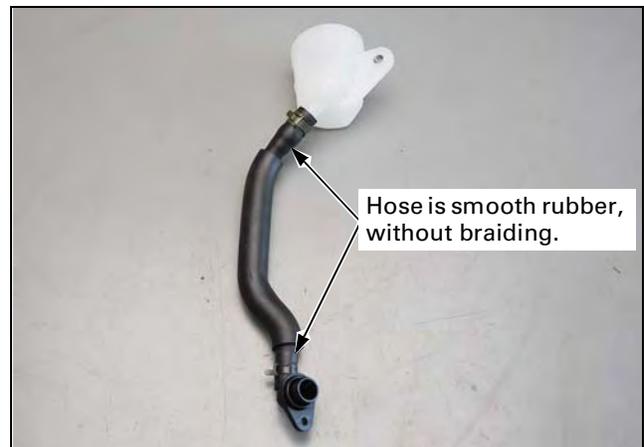
The hose portion of the update part is smooth rubber, without braiding.

43570-MCS-305
